# ARMY MIDAIR

# COLLISIONS

PREPARED BY THE U. S. ARMY BOARD FOR AVIATION ACCIDENT RESEARCH ■ FORT RUCKER, ALABAMA

**I. ABSTRACT.** This report contains analyses of 56 Army midair collisions which occurred during the period January 1963 to November 1969 and conclusions and recommendations based on the analyses.

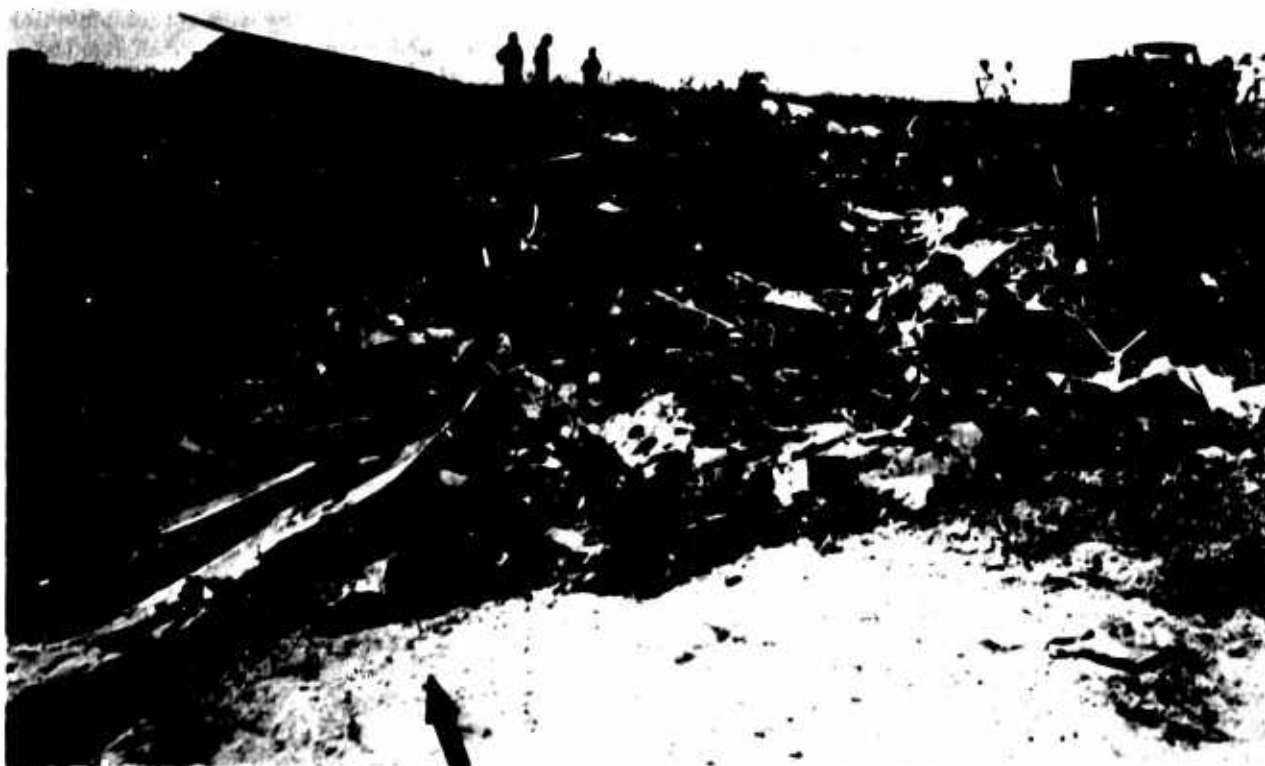
This UH-1B was one of two which collided and crashed during training, killing all four occupants and destroying both aircraft.
